THERMOGRAPHIC MEASUREMENT REPORT

Assessed for: FIRST Heating s.r.o., Revoluční 3, Praha 1, Czech Republic

Observed at: PROBAEQ s.r.o., Vrahovická 41, Prostějov, Czech Republic

The objective was to determine the heating properties of infrared heating panels manufactured by FIRST Heating. Two measurements were performed:

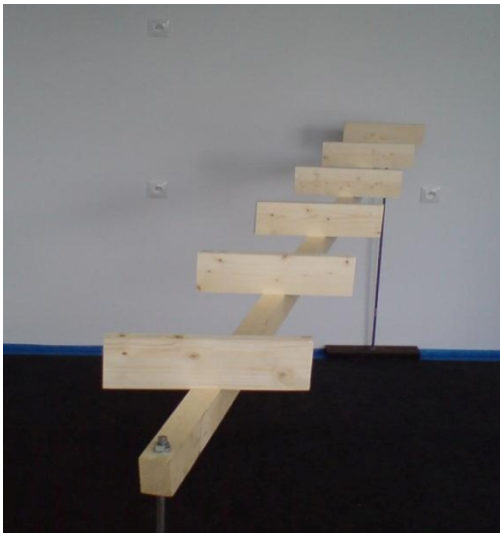
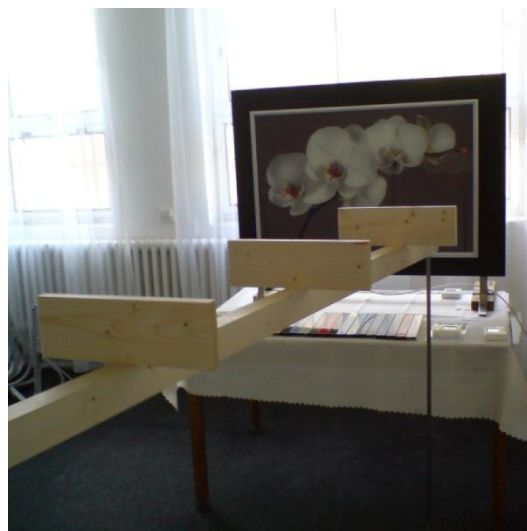
Figure 3 – Arrangement of the objects for evaluation, thermographic samples.

Temperature measurements were made on wooden boards (see Figure 3 below).

Six individual boards were spaced at distances of 0.5m from each other in a row, beginning at 0.5m from the heating panel. The temperatures of the boards were recorded every 5 minutes for a period of 120 minutes. A 600mm x 900mm heating panel was used in this observation. Measurements were performed with a thermal camera and contact thermometer. The results are listed in Table 2, the graph of temperatures in Figure 4, and in the Annex of thermal images.

It is evident from the measurement results that the greatest temperature increase (about 5°C) occurred within the first 20 minutes. Further increase of temperature slowed for the remainder of the evaluation to about 2°C.

All of the boards up to a distance of 3m gained temperature. Some then had slight reductions of temperature near the end of the measurement. The final temperature difference between boards nearest and most distant from the heating panel was nearly 3°C.
